Granada House Condominiums
SIRS Components
Pompano Beach, FL

Report #: 37253-0
Beginning: January 1, 2024
Expires: December 31, 2024

RESERVE STUDY
"Full"

October 20, 2023

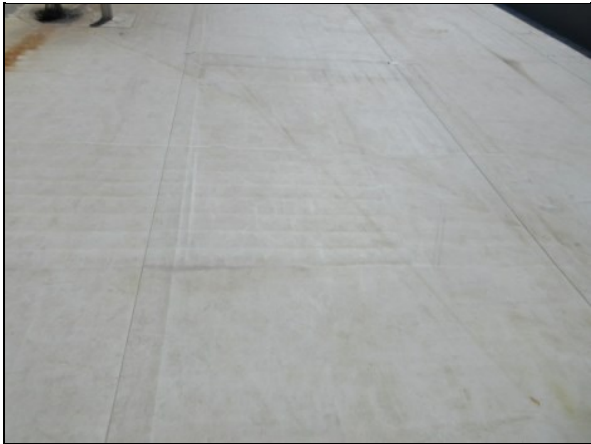
Comp #: 2378 Single Ply Roofing - Replace

Useful Life:
20 years

Remaining Life:
16 years
